## Technology of three-dimensional laser scanning as a tool to provide safety for sport facilities

**FOR CITATION:** Gura D.A., Bespyatchuk D.A., Samarin S.V., Kiryunikova N.M., Lesovaya E.D. Technology of three-dimensional laser scanning as a tool to provide safety for sport facilities. *Nanotechnologies in Construction*. 2021; 13(4): 259–263. Available from: doi: 10.15828/2075-8545-2021-13-4-259-263.

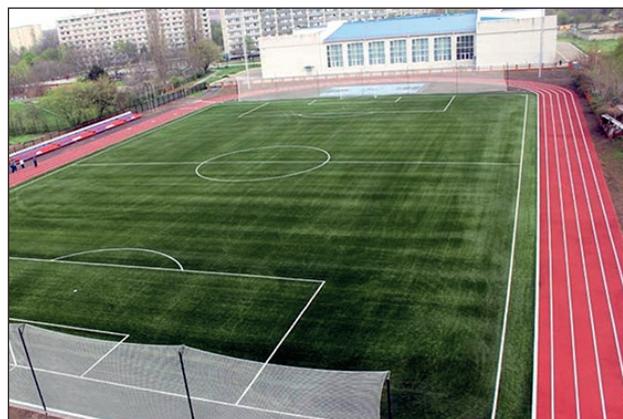
Fig. 1. The athletic stadium of Kuban State Technological University

To inspect safety of racetracks, the athletic stadium of Kuban State Technological University (KubSTU), which location is Krasnodar, Moskovskaya str., bld. 2, has been chosen. The photography of it is in Fig. 1.

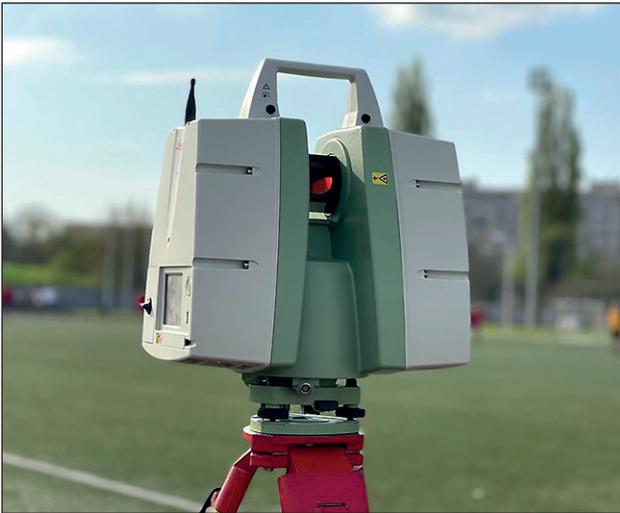
Fig. 2. Laser scanner Leica ScanStation C10

Scanning was performed with the laser scanner Leica ScanStation C10. The photography of the scanner is in Fig. 2.

The research group set following parameters when scanning athletic stadium of Kuban State Technological University: discretion 10x10 cm, exposure time 64 sec, resolution 1920x1920 pixels, scanning coverage was 360x270°, scanning process ran from 6 stations. After scanning, point cloud was imported into special software Leica Cyclone to render objects.

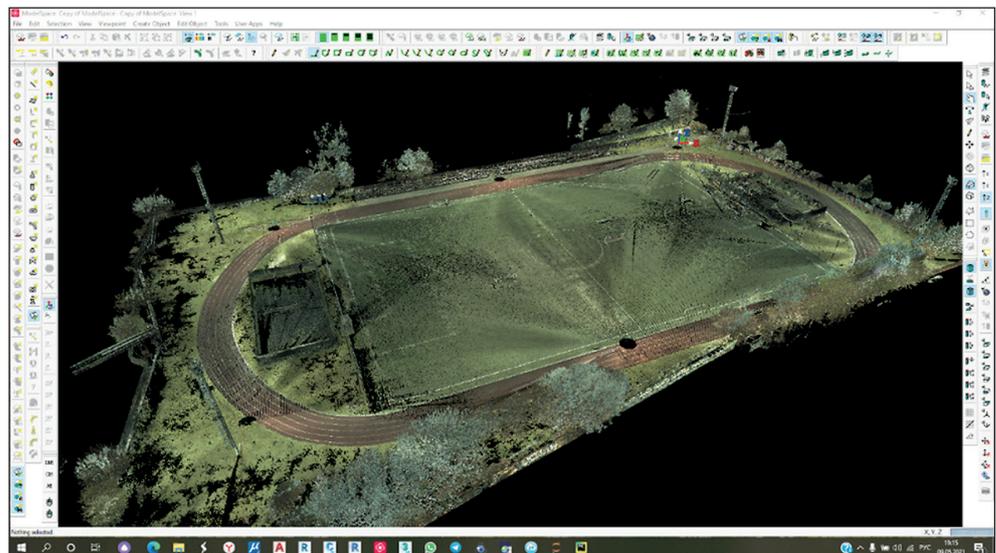
Fig. 3. Point cloud  
Processed in software  
Leica Cyclone

Rendered stadium in software Leica Cyclone is in Fig. 3.

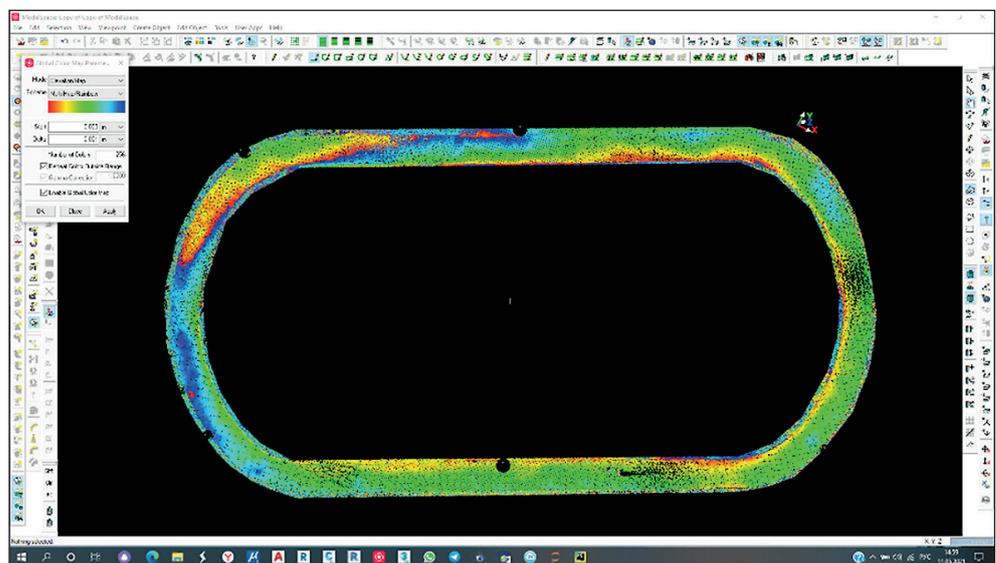
Fig. 4. Rendered  
cloud, which points  
were classified by the  
height in software  
Leica Cyclone

Having rendered the stadium, the points of racetrack were classified by height. Each height value was assigned color. An array of points with colors corresponding to their height is presented in Fig. 4.

One should note that colors correspond to the following height values:

- green – 0–2 mm;
- blue – 2–3 mm;
- yellow – 3–5 mm;
- orange – 5–7 mm;
- red – 7–8 mm;
- black – 8–9 mm.
